IIT GANDHINAGAR

SAFETY MATTERS

TAKSHASHILA ARCADE FIRE AT SURAT: A TECHNICAL ANALYSIS | ABHAY D PURANDARE

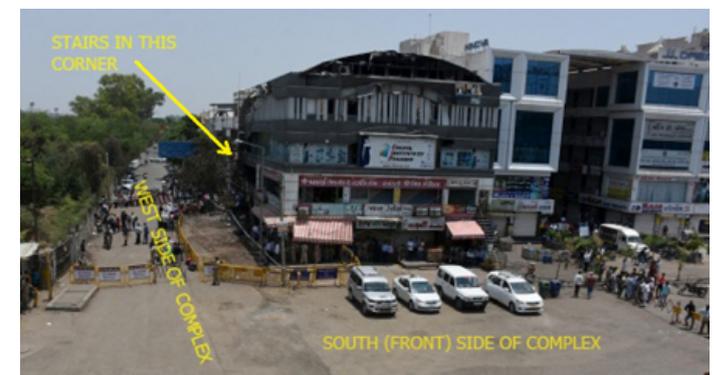
Takshashila Arcade in Sarthana area of Surat is a commercial building, approximately 30 metres long by 15 metres wide, having G+3 floors. As per information available through media reports[1], the terrace was later covered and used as a floor (thus technically making it G+4 floors). The building is oriented north to south lengthwise and has roads on the south and west side (Sarthana Jakat Naka-Kamrej road on South sidewith a clear width of over 12.0 metres, and a 6.0 metre wide road on west side). There is another commercial complex adjacent to it on the east side and a 2 storey villa on the north side. From a fire brigade access point of view, the south and west side of the complex are easily accessible.

Figure 3. Complex layout and access (Image Source: 1)

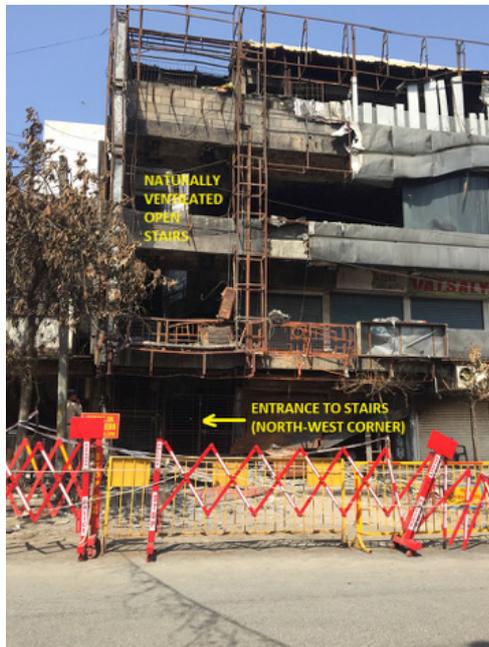
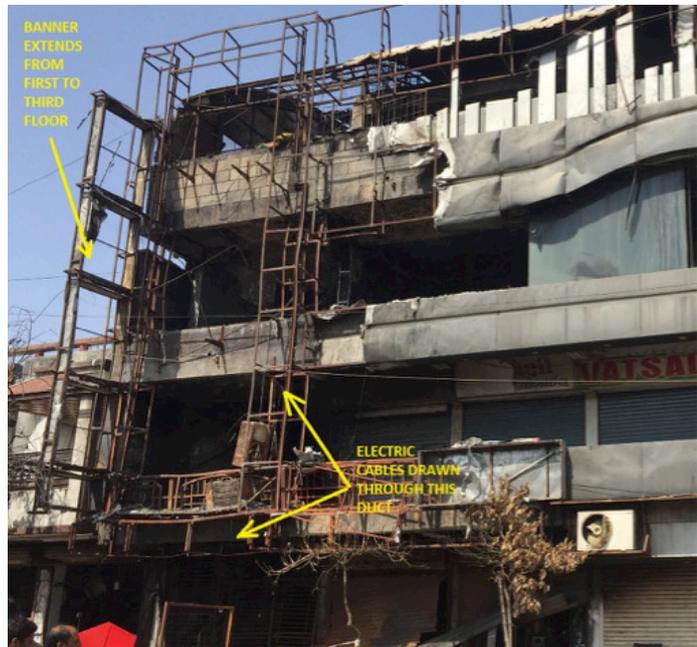
There is a single concrete stair of approx. 1.2 metre width, located in the north-west corner, extending from ground to third floor; this exits directly on the road (on west side). As per media reports, access to the fourth floor was added later on and this was fabricated out of steel frame with wooden treads/ landing. The stairs being naturally ventilated (open from one side), should logically not allow accumulation of smoke; however, this is what happened in the incident. Electric meters are located below the staircase at ground floor, and cables for upper floors passed through a duct above the stair entrance (where it is believed the fire originated). On one side of the stairs (North-west corner) an illuminated banner (steel frame covered with plastic fabric or sheet) was fixed; this extended from the first to the third floor. On the other side of the stair is the enclosed duct carrying electrical cables (Refer Fig. 4).

Figure 4. Egress arrangements of Building (Image Sources: 2,3)

The fire protection arrangement within the complex seems to have been limited to portable extinguishers. Fixed fire protection systems (such as dry riser with hose reels and fire brigade inlet) are not seen in the complex.

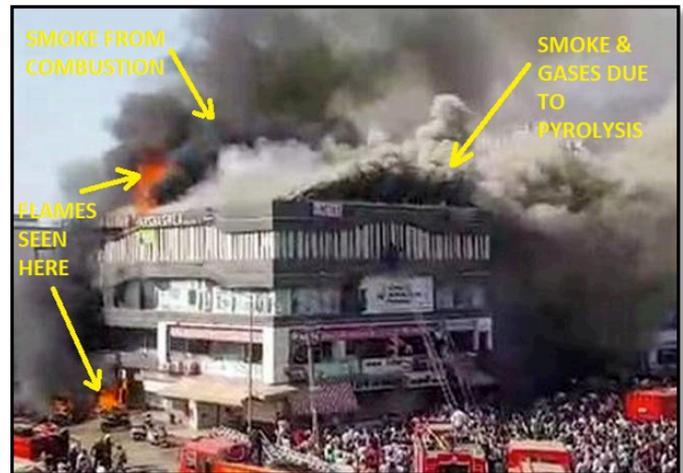
All available information points out to the ignition of electric cables above the stair entrance exit. The electrical duct cover (plastic/laminates?) later ignited, and due to the resultant heat, at least four 2-wheelers parked close by also caught fire. Once the plastic banner adjacent to the stairs and electric cable duct ignited, it allowed flames to travel up vertically quickly. It appears that material was stored near the stairs on the fourth floor and flames and hot smoke finally ignited the pyrolyzing material kept here, and flames were seen on the fourth floor, but not on the second and third floors (See Fig. 5).

Figure 5. Fire Incident In Progress (Image Source: 4)

The smoke generated due to burning materials was being pushed into the stair due to the wind direction prevalent at that time (from the west direction; wind velocity in this period averages 10-15 kmph. This allowed the hot smoke to enter and pyrolyze (and finally ignite) the materials on the fourth floor (most likely furniture using laminated wood, polymers (plastic furniture, foam used in furniture, lining material). It is also stated that rubber tyres were used to create seating arrangement for students, which would have generated dense, acrid smoke on ignition.
